# Check-in Inventory Report

Sample No Sample Road, Sample Town, Sample County, England, Sample Post Code

This is a furnished three bedrooms house with front and back gardens.

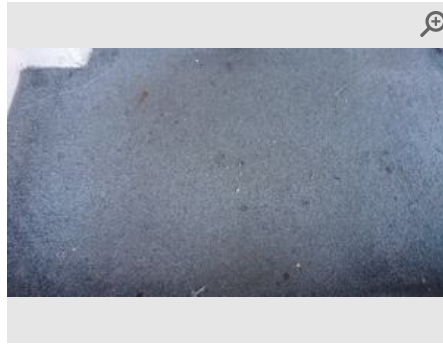
| Reference | <b>2.6.1</b> |

| Item | Description | Condition | Cleanliness | Photos |
|---|---|---|---|---|
| <b>Floor</b><br>2.6 | Carpeted. Worn carpet. Loose fitting carpet. Loose debris present | ● Good | ● Good | 📷 2 photos |

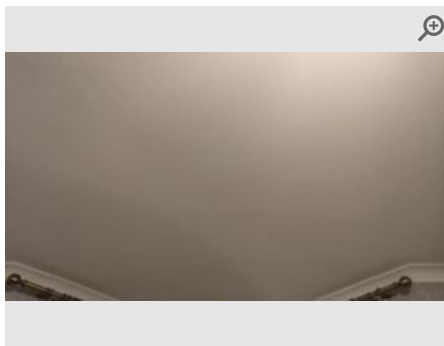
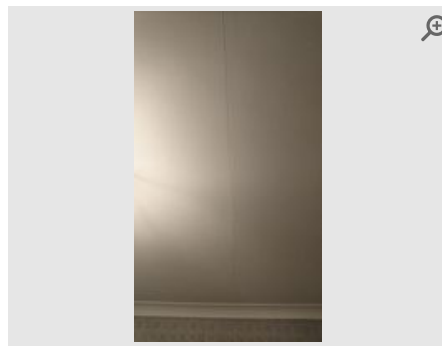
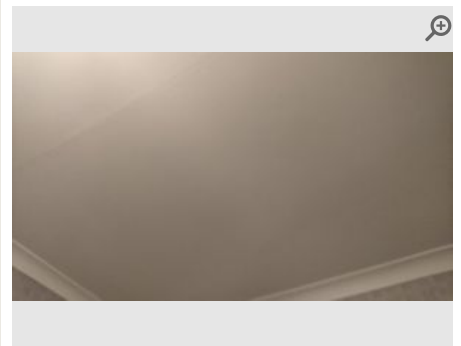
| Item | Description | Condition | Cleanliness | Photos |
|---|---|---|---|---|
| <b>Ceiling</b><br>4.3 | Plastered/Painted white. Hairline crack present. Free of cobwebs/dust | ● Fair | ● Good | 📷 3 photos |

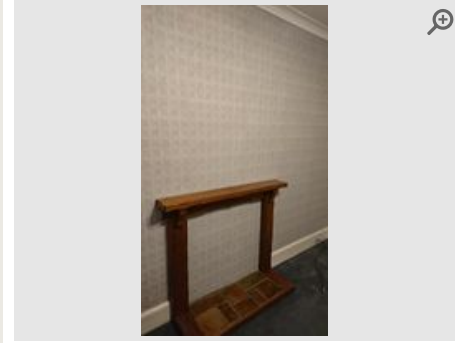
| Reference | <b>4.5.2</b> |

| Item | Description | Condition | Cleanliness | Photos |
|---|---|---|---|---|
| <b>Walls</b><br>4.5 | Wallpapered/painted white. Raw plug/nail holes present<br>Free of marks stains and scuffs. | ● Fair | ● Good | 📷 4 photos |

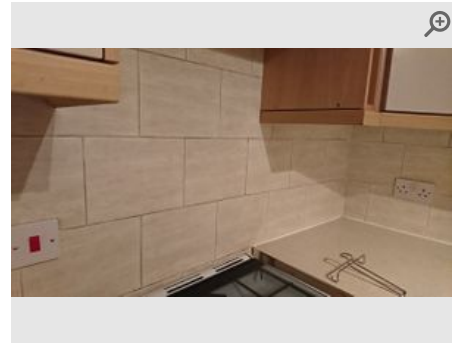
| Reference | <b>6.5.2</b> |

| Item | Description | Condition | Cleanliness | Photos |
|---|---|---|---|---|
| <b>Walls</b><br>6.5 | Plastered & painted magnolia. Tiled (around worktops)<br>Free of marks stains and scuffs. Numerous holes present. Tiles cracked. | ● Fair | ● Fair | 📷 6 photos |

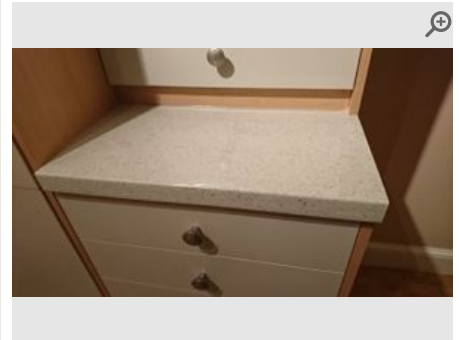
| Reference | <b>6.9.2</b> |

| Item | Description | Condition | Cleanliness | Photos |
|---|---|---|---|---|
| <b>Kitchen Worksurfaces</b><br>6.9 | Laminated worksurface. Charcoal<br>Free of marks and scratches. Stains present. | ● Good | ● Fair | 📷 5 photos |

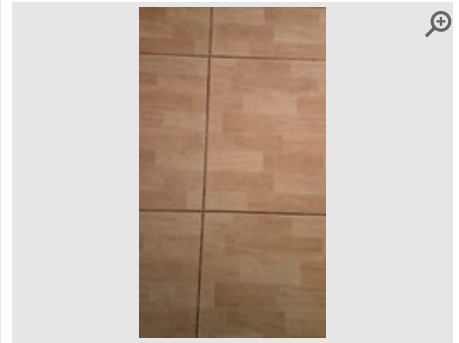
| Reference | <b>6.20.2</b> |

| Item | Description | Condition | Cleanliness | Photos |
|---|---|---|---|---|
| <b>Floor</b><br>6.20 | Tiled. Magnolia<br>Stains present, marks and scratches. | Good | Fair | 3 photos |

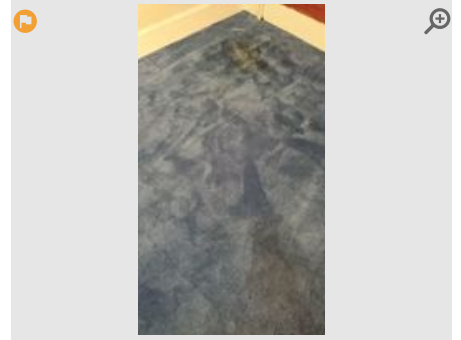
| Reference | <b>11.9.2</b> |

| Item | Description | Condition | Cleanliness | Photos |
|---|---|---|---|---|
| <b>Floor</b><br>11.9 | Carpeted. Blue (pale)<br>Stains present. | ● Good | ● Fair | 📷 4 photos |
