# Check-in Inventory Report

Sample No Sample Road, Sample Town, Sample County, England, Sample Post Code

This is a furnished three bedrooms house with front and back gardens.

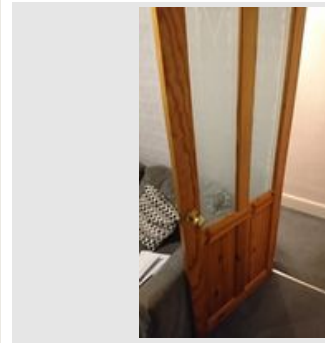
| Reference | <b>4.2.2</b> |

| Item | Description | Condition | Cleanliness | Photos |
|---|---|---|---|---|
| <b>Door (Internal)</b><br>4.2 | Wood panelled; brass handle. Natural wood (varnished). Glazed panel above door. Brown<br>Free of marks and scratches to front side and reverse. Door frame is damaged | ● Fair | ● Good | 📷 3 photos |

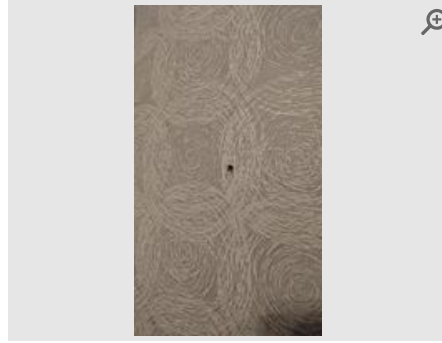
| Reference | <b>4.5.1</b> |

| Item | Description | Condition | Cleanliness | Photos |
|---|---|---|---|---|
| <b>Walls</b><br>4.5 | Wallpapered/painted white. Raw plug/nail holes present<br>Free of marks stains and scuffs. | ● Fair | ● Good | 📷 4 photos |

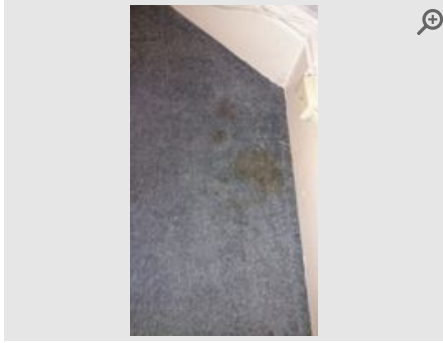
| Reference | <b>4.10.1</b> |

| Item | Description | Condition | Cleanliness | Photos |
|---|---|---|---|---|
| <b>Floor</b><br>4.10 | Blue (pale)<br>Carpeted. Stain marks present. | ● Good | ● Fair | 📷 2 photos |

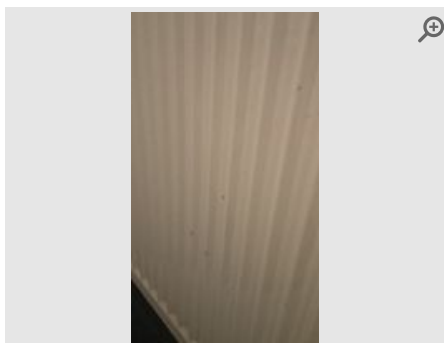
| Reference | <b>5.7.1</b> |

| Item | Description | Condition | Cleanliness | Photos |
|---|---|---|---|---|
| <b>Radiator</b><br>5.7 | White panelled. 1 in total<br>Wall mounted radiator. All valve caps present and intact. Stains present. | ● Good | ● Fair | 📷 2 photos |

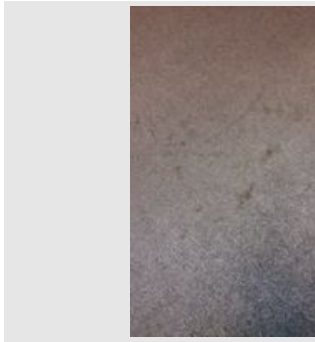
| Reference | <b>5.9.1</b> |

| Item | Description | Condition | Cleanliness | Photos |
|---|---|---|---|---|
| <b>Floor</b><br>5.9 | Carpeted. Blue (pale)<br>Stains present. | ● Good | ● Fair | 📷 2 photos |

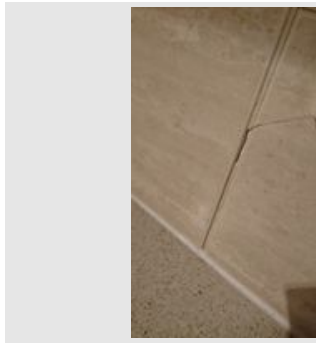
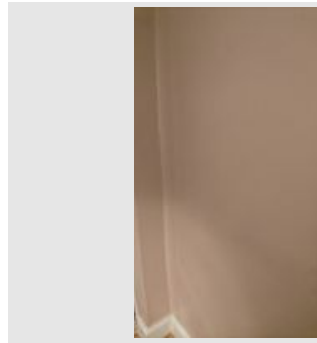
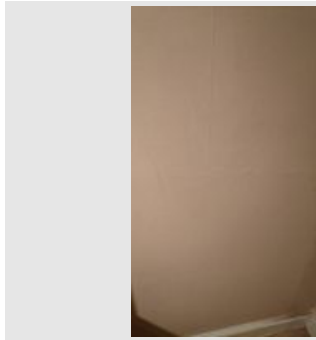
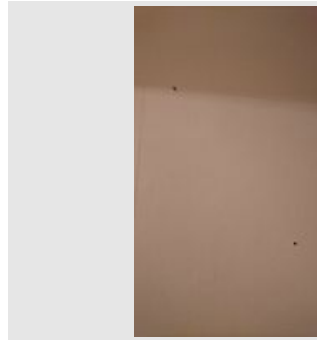
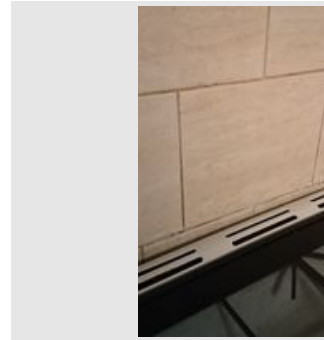
| Item | Description | Condition | Cleanliness | Photos |
|---|---|---|---|---|
| <b>Walls</b><br>6.5 | Plastered & painted magnolia. Tiled (around worktops)<br>Free of marks stains and scuffs. Numerous holes present. Tiles cracked. | ● Fair | ● Fair | 📷 6 photos |

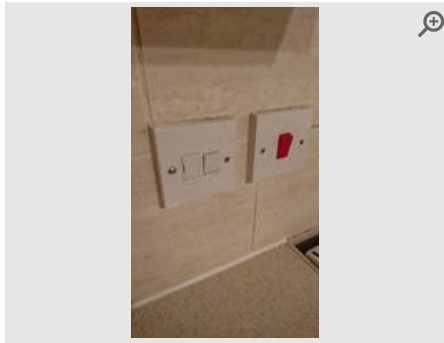
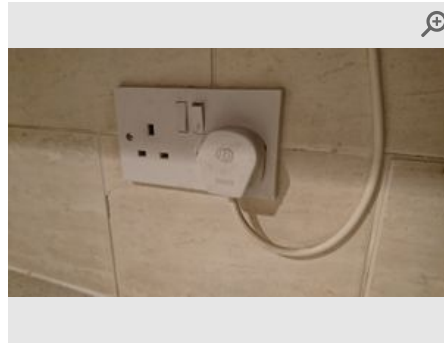
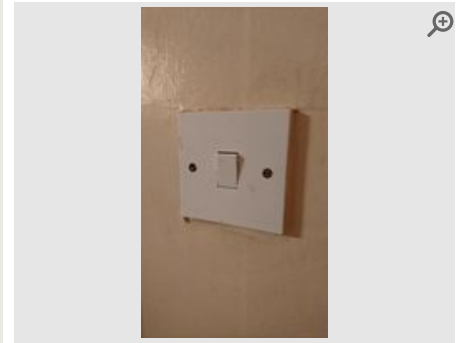
| Item | Description | Condition | Cleanliness | Photos |
|---|---|---|---|---|
| <b>Sockets &amp; Switches</b><br>6.7 | All sockets/switches plastic<br>All sockets and switches present and intact with no signs of damage. | ● Good | ● Good | 📷 3 photos |

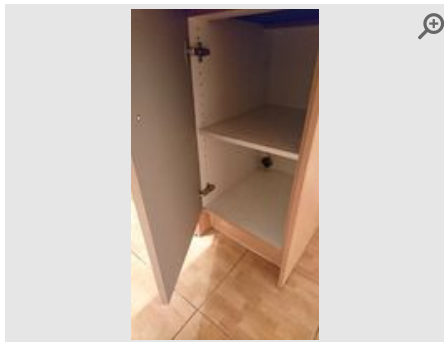
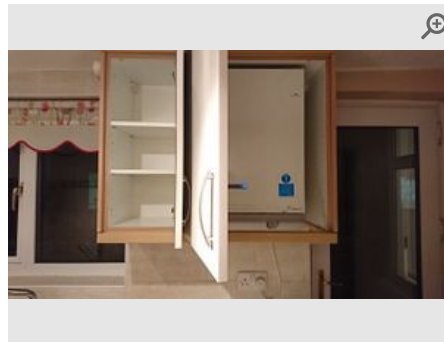
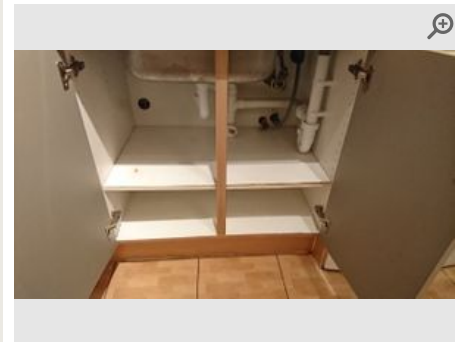
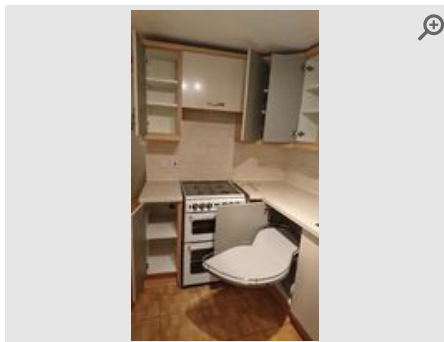
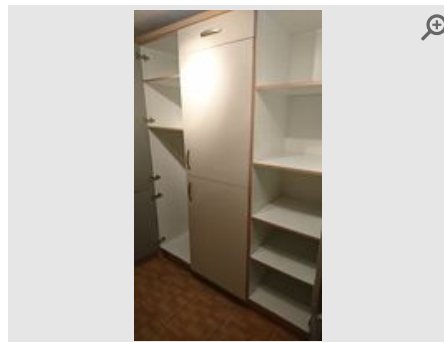
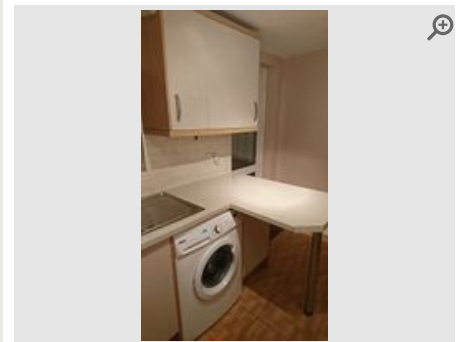
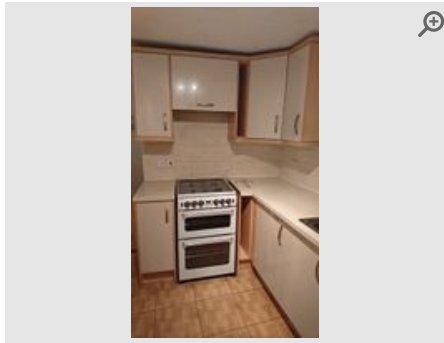
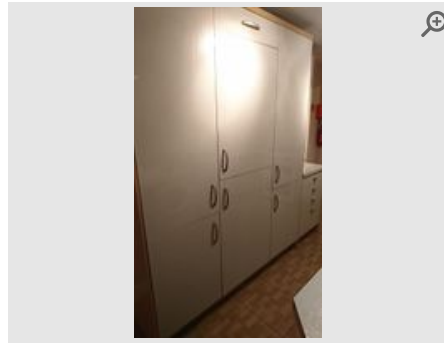
| Item | Description | Condition | Cleanliness | Photos |
|---|---|---|---|---|
| <b>Kitchen Cupboards/Units</b><br>6.8 | Wall units present. Base units present. Laminate wood effect. Chrome handles.<br>Laminated shelving. Brown. White<br>All handles and hinges intact. Free of items inside. Free of stains underneath sink.<br>Free of grease and food residue inside. | ● Good | ● Fair | 📷 8 photos |

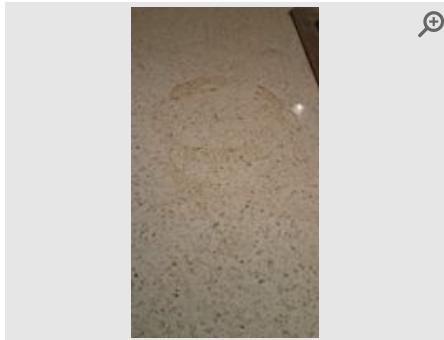
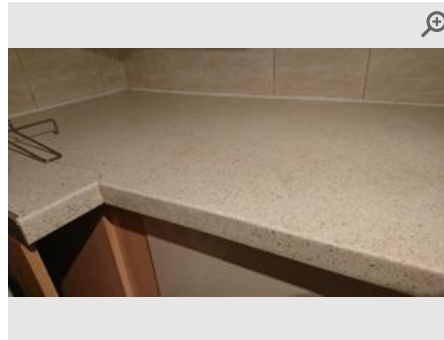
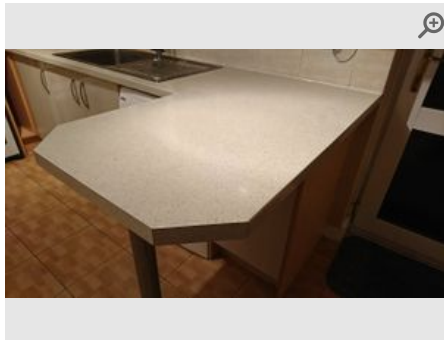
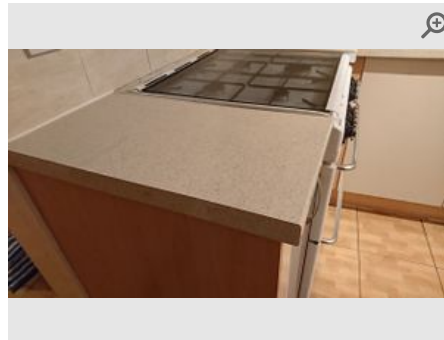
| Item | Description | Condition | Cleanliness | Photos |
|---|---|---|---|---|
| <b>Kitchen Worksurfaces</b><br>6.9 | Laminated worksurface. Charcoal<br>Free of marks and scratches. Stains present. | ● Good | ● Fair | 📷 5 photos |

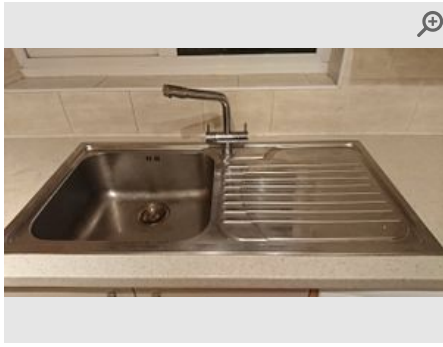
| Reference | <b>6.10.1</b> |

| Item | Description | Condition | Cleanliness | Photos |
|---|---|---|---|---|
| <b>Kitchen Sink</b><br>6.10 | Single bowl. Stainless steel. Mixer tap. Lever taps. Chrome taps. Chrome plug<br>Free of scratches and cracks. No food residue or grease present. | ● Good | ● Good | 📷 1 photo |

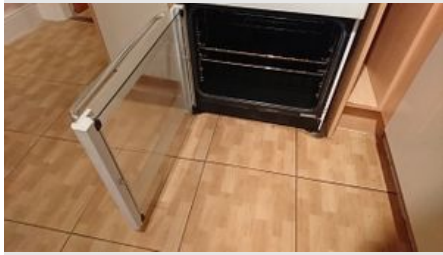
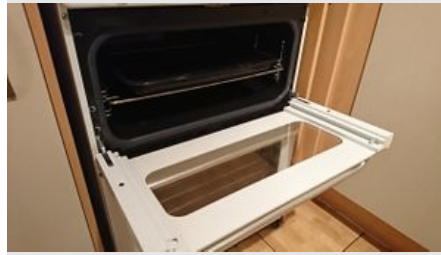
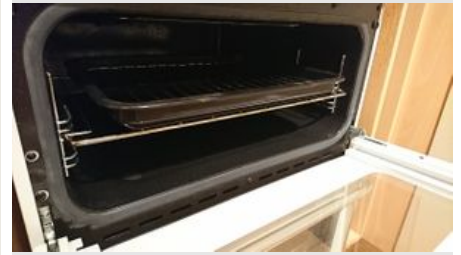
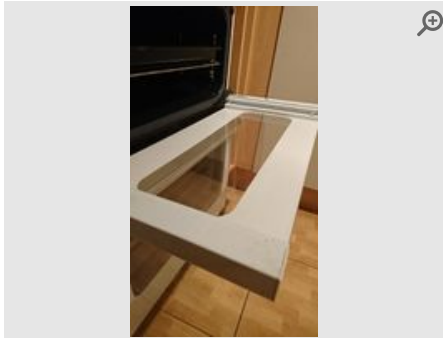
| Item | Description | Condition | Cleanliness | Photos |
|---|---|---|---|---|
| <b>Oven</b><br>6.12 | Double oven. Electric cooker. Chrome rack x 3. Baking tray x 1. New<br>Grease and food residue inside present. Seal intact and door hinge functioning<br>smoothly. Door glass is missing inside on the top oven. | ● Poor | ● Good | 📷 4 photos |

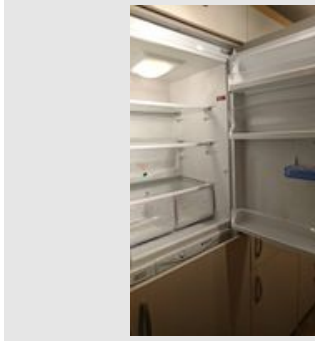
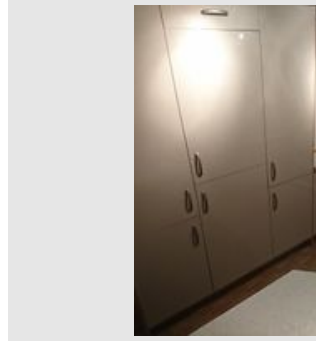
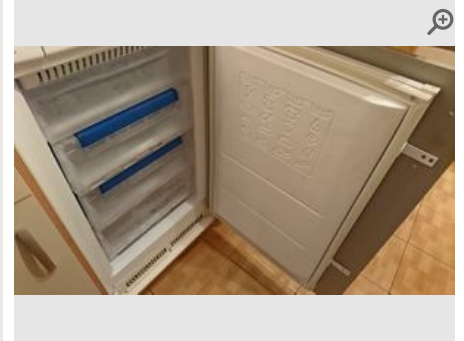
| Item | Description | Condition | Cleanliness | Photos |
|---|---|---|---|---|
| <b>Fridge Freezer (Integrated)</b><br>6.14 | Upright. 6 Shelves. Egg tray. Internal light. Ice dispenser. Hotpoint<br>Clean and free of food residue inside. No cracks or damage to trays and shelving.<br>Bulb in working order. | ● Good | ● Good | 📷 3 photos |

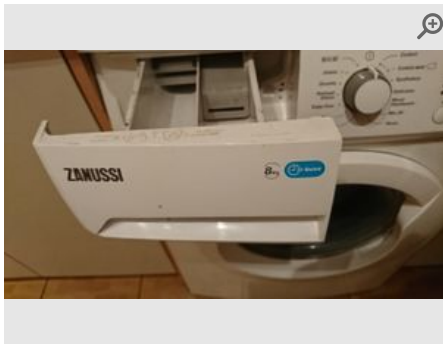
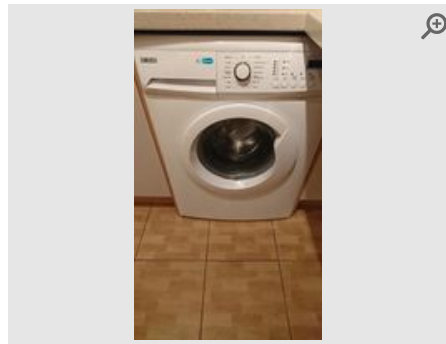
| Item | Description | Condition | Cleanliness | Photos |
|---|---|---|---|---|
| <b>Washing Machine</b><br>6.15 | Front loader. Zanussi. White<br>Seal is clean and intact. No signs of damage to drum inside. Door hinge is functioning<br>smoothly. Detergent drawer is clean. | ● Good | ● Fair | 📷 2 photos |

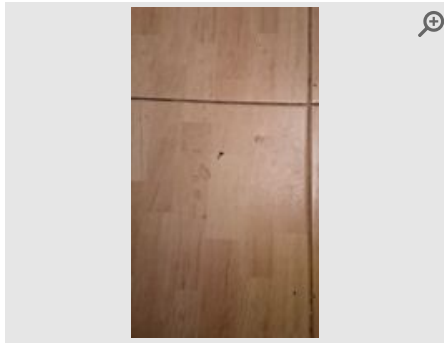
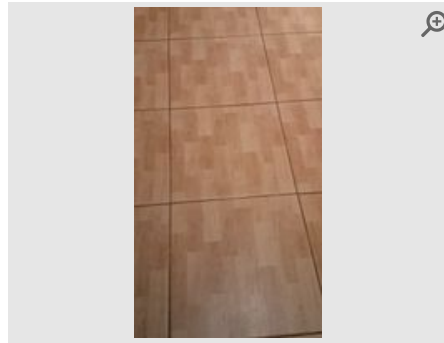
## Floor

| Item | Description | Condition | Cleanliness | Photos |
|---|---|---|---|---|
| <b>Floor</b><br>6.20 | Tiled. Magnolia<br>Stains present, marks and scratches. | Good | Fair | 3 photos |

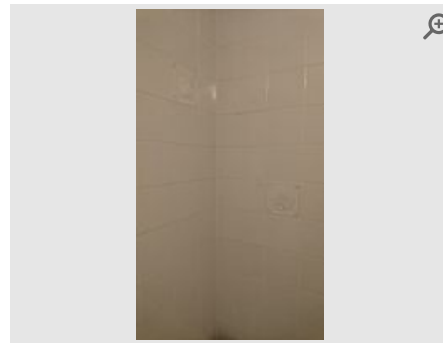
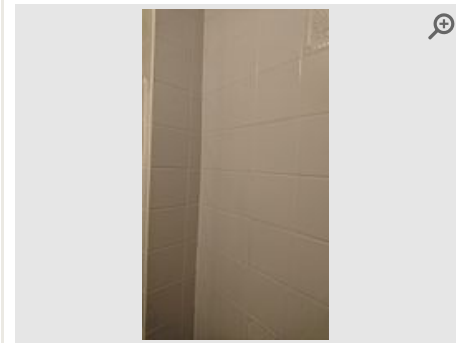
## Walls

| Item | Description | Condition | Cleanliness | Photos |
|---|---|---|---|---|
| <b>Walls</b><br>7.7 | Plastered & painted magnolia. Tiled (around wet areas)<br>Free of marks stains and scuffs. No picture hooks, raw plug or filled holes present. | ● Good | ● Good | 📷 3 photos |

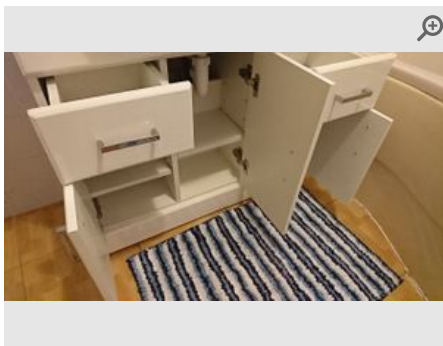
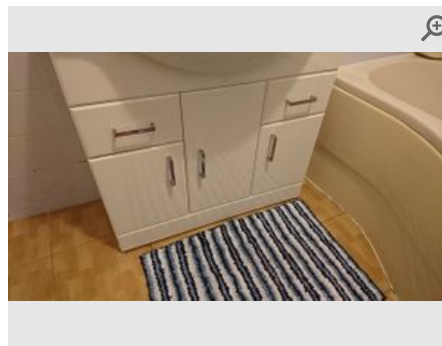
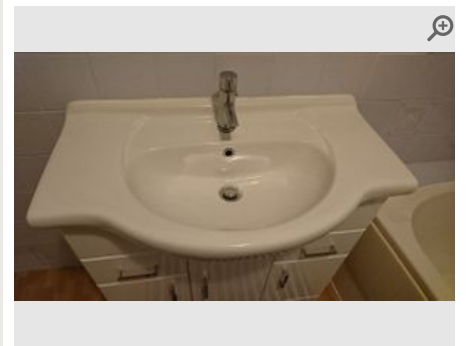
## Sink/Basin

| Item | Description | Condition | Cleanliness | Photos |
|---|---|---|---|---|
| <b>Sink/Basin</b><br>7.11 | Semi ped porcelain. Mixer tap. Chrome taps. Chrome plug. Cream<br>Base unit present. Basin intact and free of cracks/chips. No gaps to sealant around edges. Clean and free of hairs. No limescale present to taps. | ● Good | ● Good | 📷 3 photos |

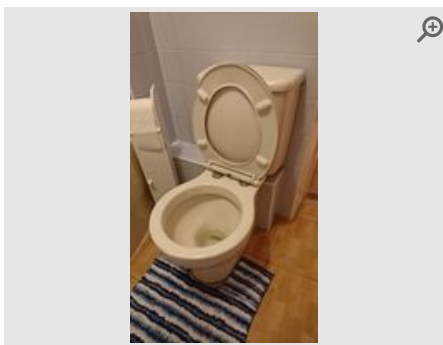
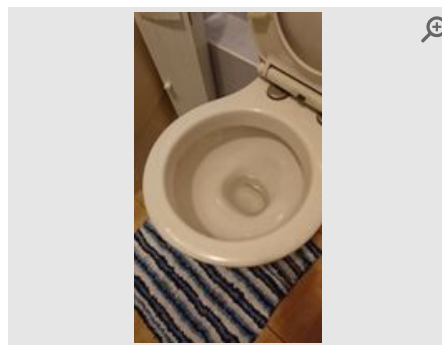
## Toilet

| Item | Description | Condition | Cleanliness | Photos |
|---|---|---|---|---|
| <b>Toilet</b><br>7.12 | Porcelain. Plastic/Acrylic seat & lid. Flush button. Cream<br>Free of cracks/chips. Flush intact. Seat secure and intact. Clean inside and to tank/base. | ● Good | ● Good | 📷 2 photos |

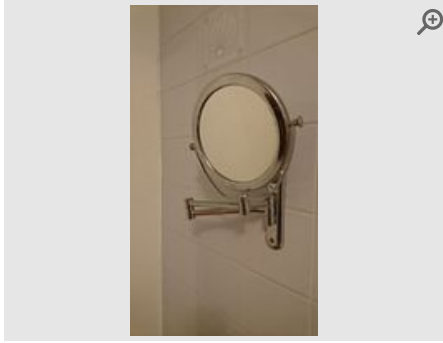
## Mirror

| Item | Description | Condition | Cleanliness | Photos |
|---|---|---|---|---|
| <b>Mirror</b><br>7.13 | Wall-mounted round. Metal frame<br>No cracks/chips. Free of smears and dust. | ● Good | ● Good | 📷 1 photo |

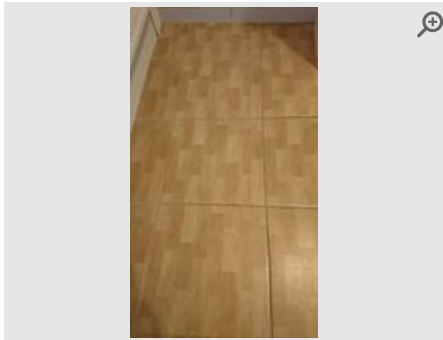
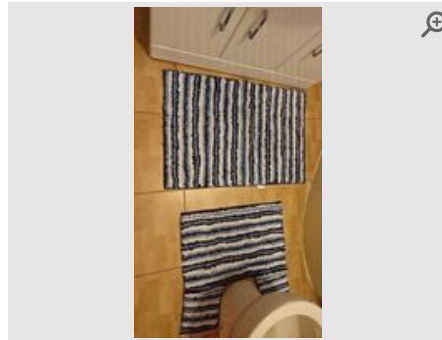
## Floor

| Item | Description | Condition | Cleanliness | Photos |
|---|---|---|---|---|
| <b>Floor</b><br>7.15 | Tiled. Brown<br>Bath mats present. Free of stains, marks and scratches. | ● Good | ● Good | 📷 2 photos |

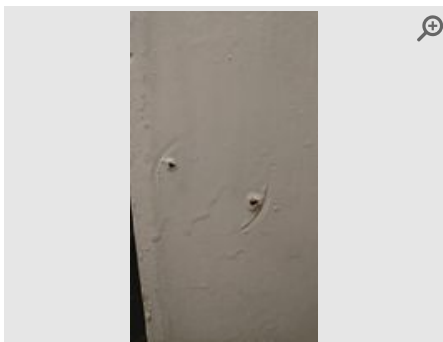
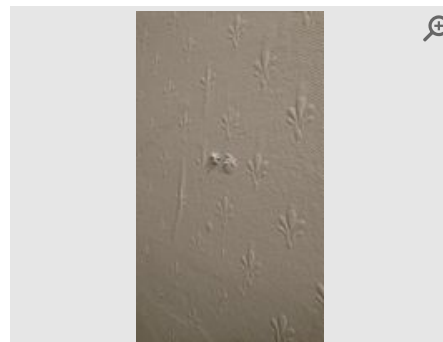
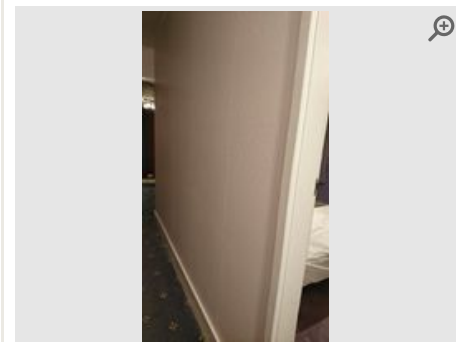
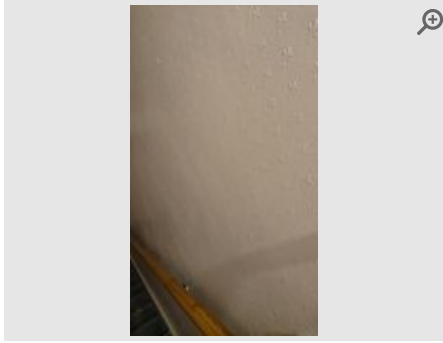
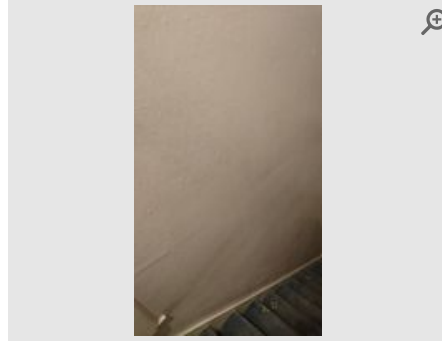
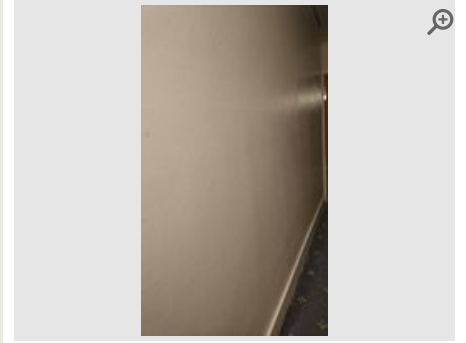
| Item | Description | Condition | Cleanliness | Photos |
|---|---|---|---|---|
| <b>Walls</b><br>8.7 | Wallpapered/painted magnolia<br>Free of marks stains and scuffs. Picture hooks, raw plug or filled holes present. | ● Good | ● Good | 📷 6 photos |

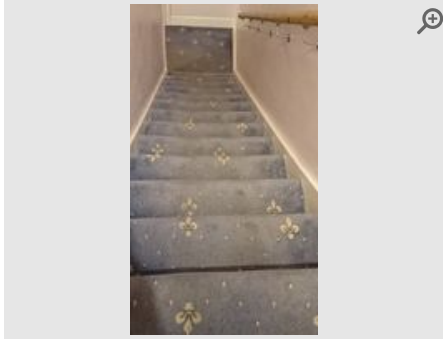
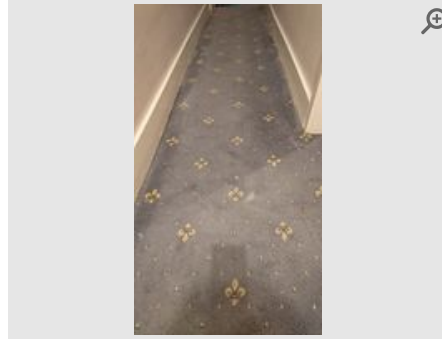
| Item | Description | Condition | Cleanliness | Photos |
|---|---|---|---|---|
| <b>Floor</b><br>8.8 | Carpeted. Blue (pale)<br>Free of stains, marks and scratches. | ● Good | ● Good | 📷 2 photos |

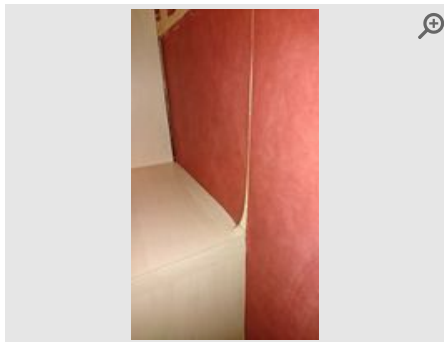
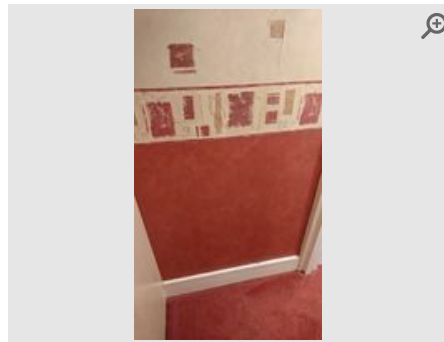
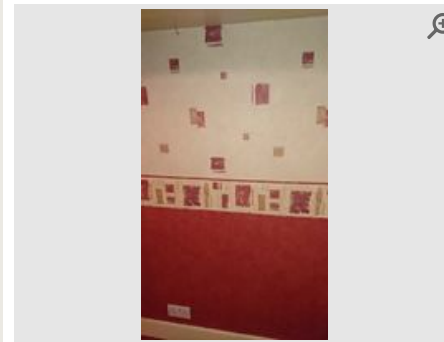
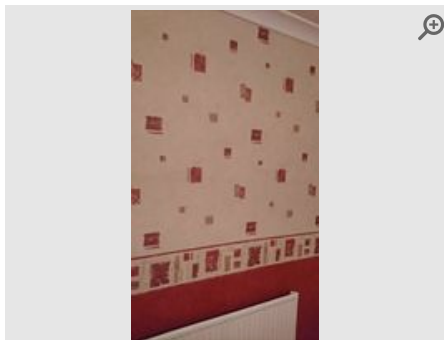
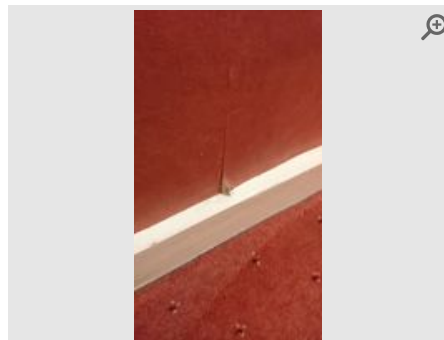
| Item | Description | Condition | Cleanliness | Photos |
|---|---|---|---|---|
| <b>Walls</b><br>9.5 | Wallpapered & painted. Pink (pale). White<br>Free of marks stains and scuffs. No picture hooks, raw plug or filled holes present.<br>Wallpaper peeling off. | ● Fair | ● Good | 📷 5 photos |

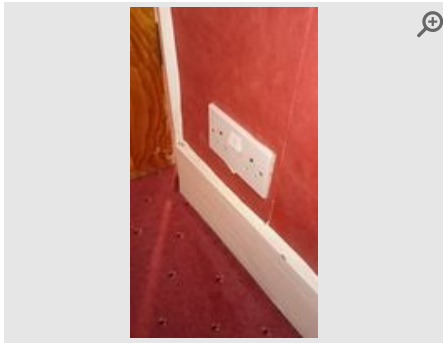
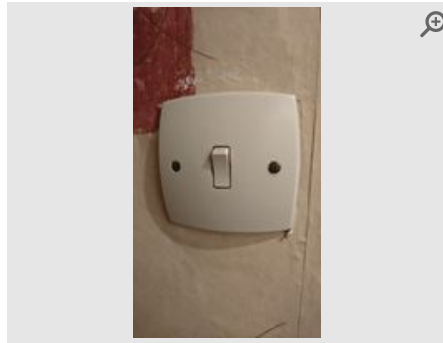
| Item | Description | Condition | Cleanliness | Photos |
|---|---|---|---|---|
| <b>Sockets &amp; Switches</b><br>9.8 | All sockets/switches plastic<br>All sockets and switches present and intact with no signs of damage. | ● Good | ● Good | 📷 2 photos |

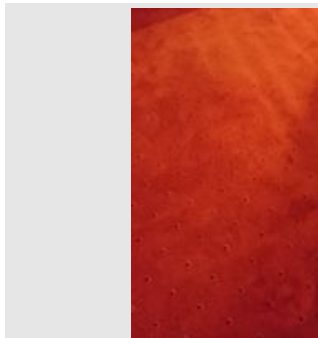
| Reference | <b>9.10.1</b> |

| Item | Description | Condition | Cleanliness | Photos |
|---|---|---|---|---|
| <b>Floor</b><br>9.10 | Carpeted. Red (pale)<br>Free of stains, marks and scratches. | ● Good | ● Good | 📷 2 photos |

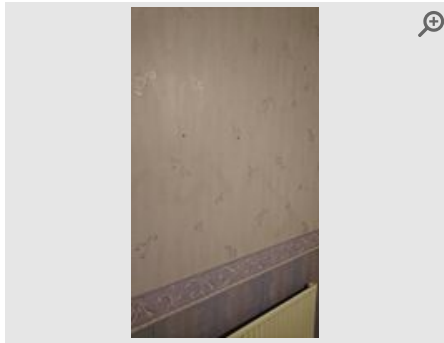
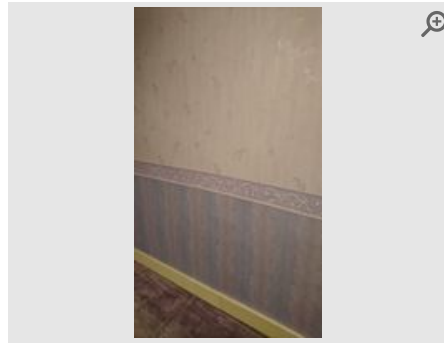
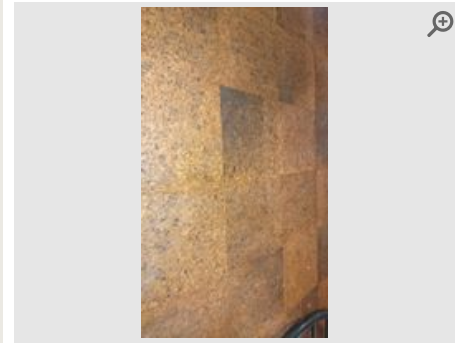
## Walls

| Item | Description | Condition | Cleanliness | Photos |
|---|---|---|---|---|
| <b>Walls</b><br>10.5 | Wallpapered & painted. Woodchip papered. Blue (pale). Bronze. White<br>Free of marks stains and scuffs. No picture hooks, raw plug or filled holes present. | ● Good | ● Good | 📷 3 photos |

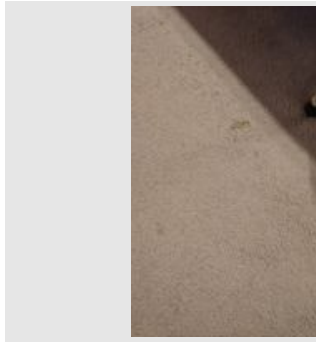
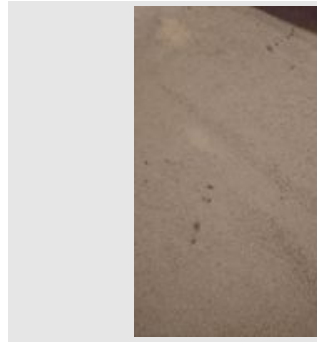
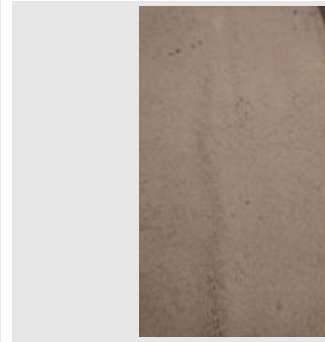
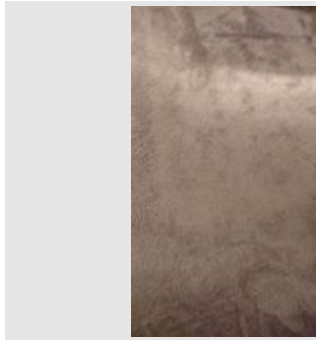
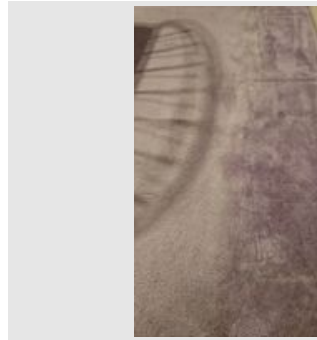
## Floor

| Item | Description | Condition | Cleanliness | Photos |
|---|---|---|---|---|
| <b>Floor</b><br>10.12 | Carpeted. Violet<br>Worn. Stains present | ● Fair | ● Fair | 📷 5 photos |

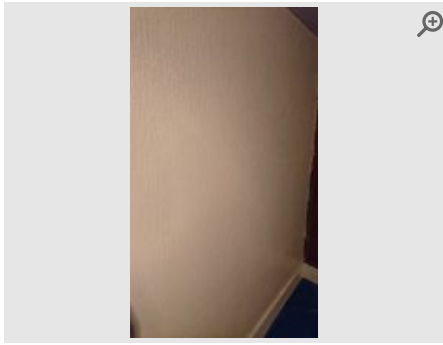
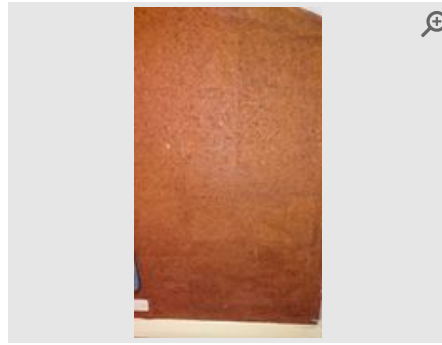
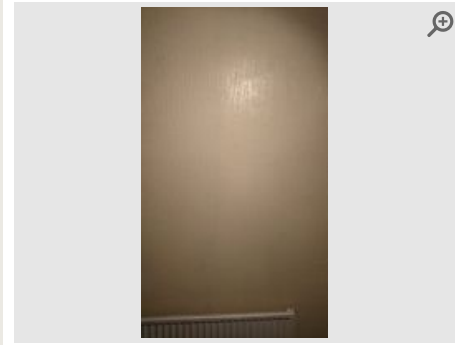
| Reference | 11.5.1 |

| Item | Description | Condition | Cleanliness | Photos |
|---|---|---|---|---|
| <b>Walls</b><br>11.5 | Wallpapered & painted. Woodchip papered<br>Free of marks stains and scuffs. No picture hooks, raw plug or filled holes present. | ● Good | ● Good | 📷 3 photos |

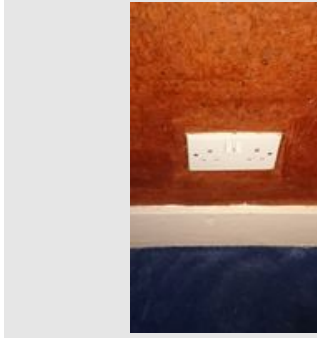
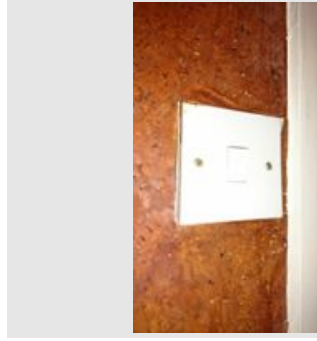
| Reference | <b>11.8.1</b> |

| Item | Description | Condition | Cleanliness | Photos |
|---|---|---|---|---|
| <b>Sockets &amp; Switches</b><br>11.8 | All sockets/switches plastic<br>All sockets and switches present and intact with no signs of damage. | ● Good | ● Good | 📷 2 photos |

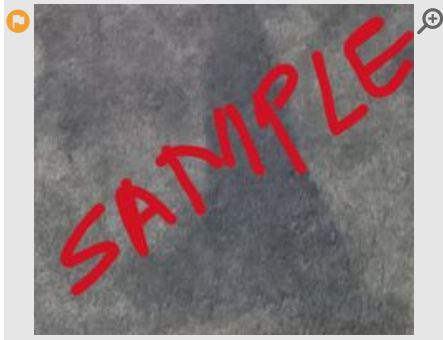
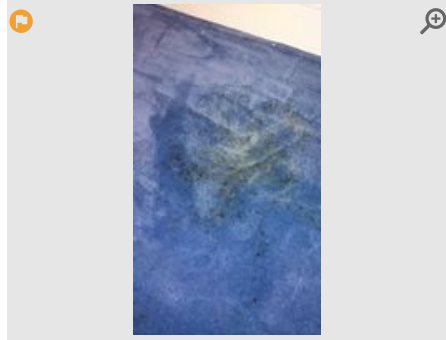
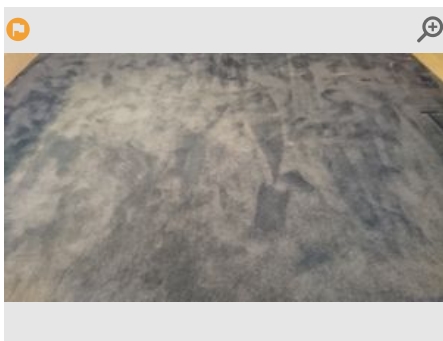
| Reference | <b>11.9.1</b> |

| Item | Description | Condition | Cleanliness | Photos |
|---|---|---|---|---|
| <b>Floor</b><br>11.9 | Carpeted. Blue (pale)<br>Stains present. | ● Good | ● Fair | 📷 4 photos |
